Subject: **Amended Inspection Report for March 22 and 23, 2012 Compliance
Evaluation Inspection**

CWA COMPLIANCE EVALUATION INSPECTION REPORT (AMENDED)
U.S. ENVIRONMENTAL PROTECTION AGENCY, REGION 5

Deer View, LLC
1487 East County Road 150
West Point, Illinois 62380

March 22 and 23, 2012

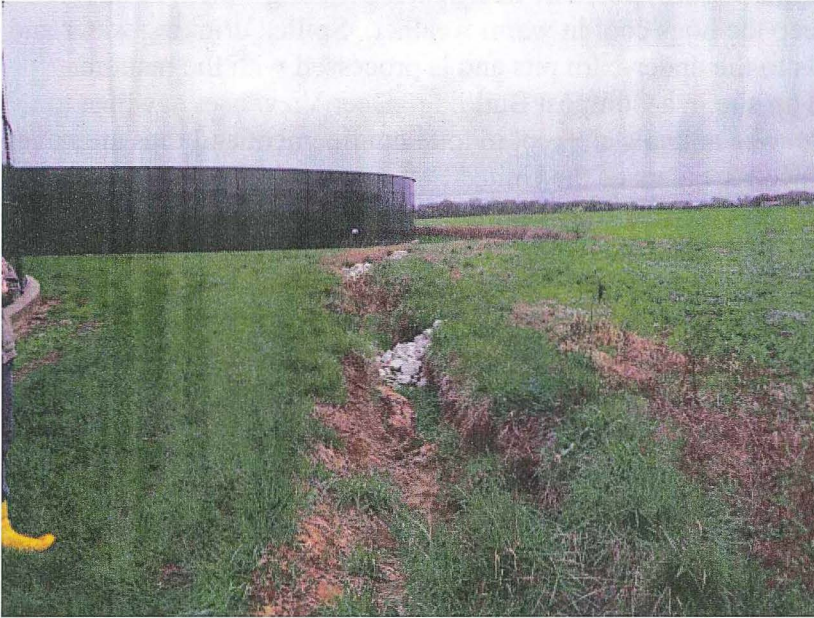
Location: North of south slurry store.

IMGP0325: Storm water pathway flows on west side of facility.

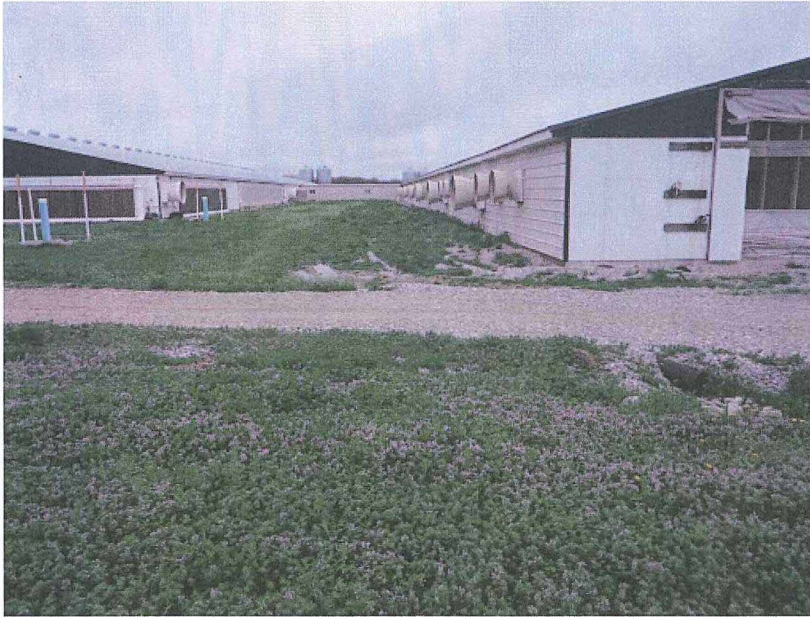
IMGP0329: Storm water pipe conveys storm water from between buildings to the north.
Location: North of Farrowing Building.
Facing: South
Date/Time: 03/22/12 1:19 P.M.

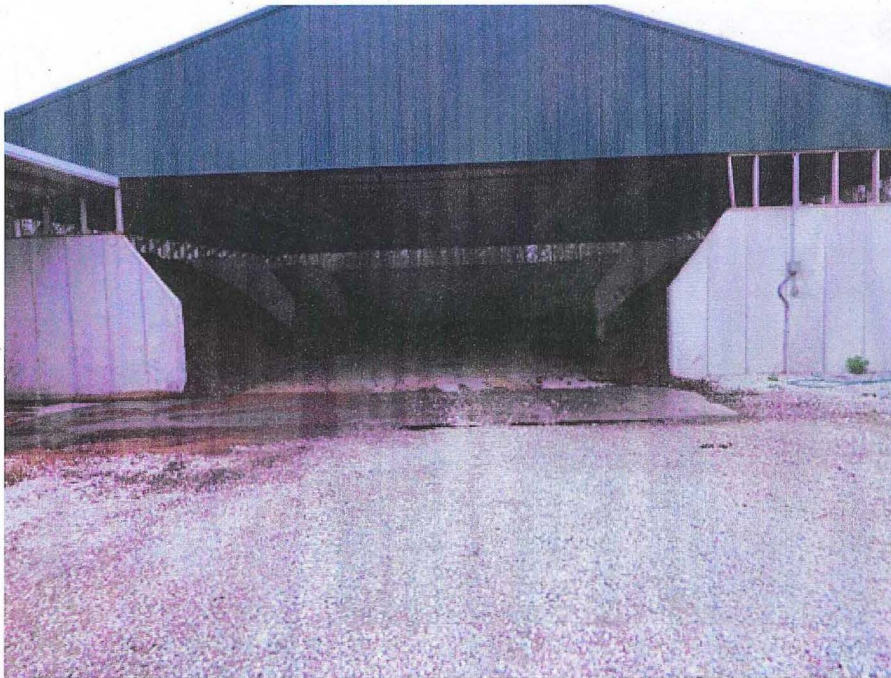
Location: Compost Building.

IMGP0330: Compost Building for composting mortalities.

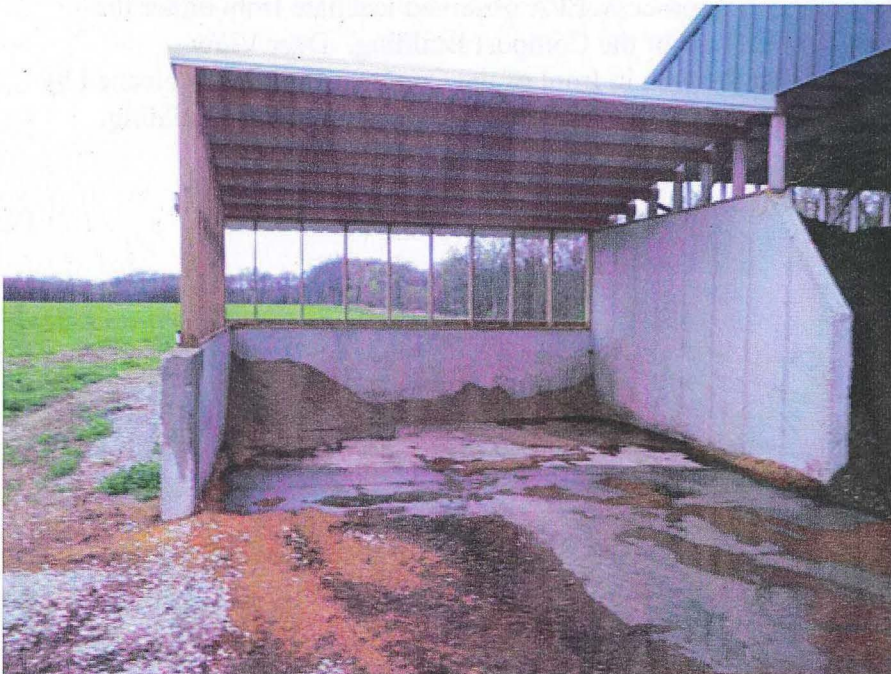
Location: Composting Building.

IMGP0331: Sawdust storage for composting process.

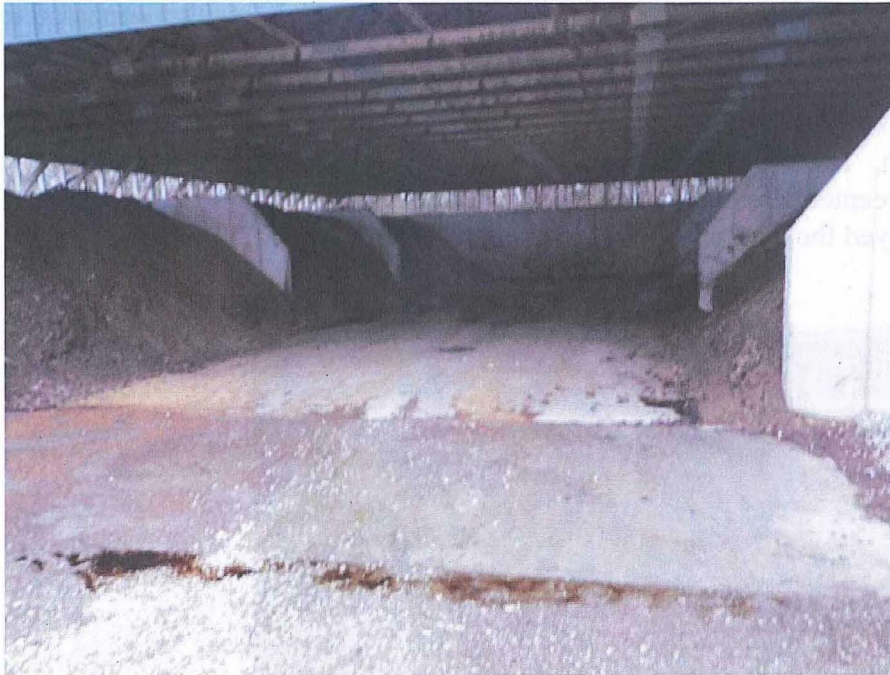
Location: Compost Building.

The Compost Building lies at the furthest northeast corner of the production area. Sawdust is used in the composting process. EPA observed leachate from either the sawdust or the compost barn in front of the Compost Building. Deer View representatives maintained that the area in front of the Compost Building is cleaned by hose on a regular basis. The leachate did not extend past the front of the building.

IMGP0332: Inside the Compost Building. Small amount of leachate at entrance.

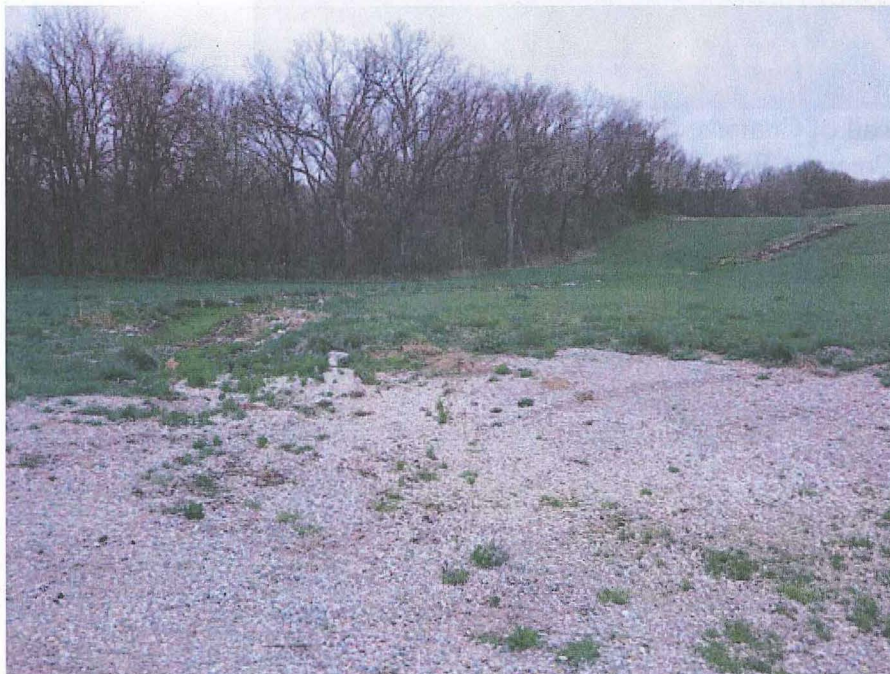
Location: Compost Building.

IMGP0333: Leachate from Compost Building did not extend to the rocks to the south of the building.

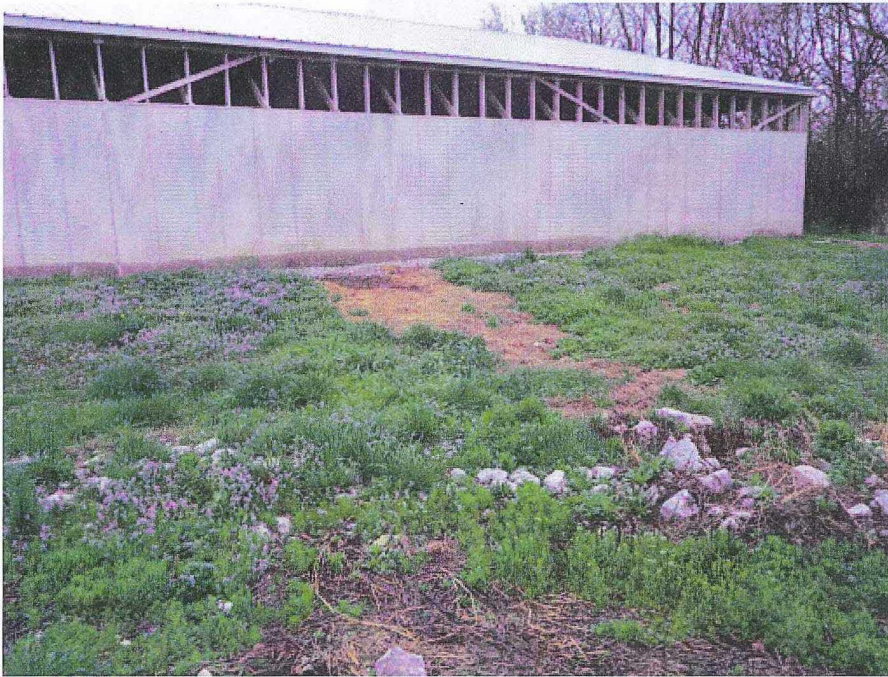
Location: South of Compost Building.

EPA identified an area on the south wall of the Compost Building that appeared to have compost leachate seeping between the wall and the concrete floor. The vegetation in front of this area appeared nutrient burned. There was no visible flow from the Compost Building to a waterway, although a storm water pathway was approximately fifty feet to the south. The storm water pathway continued downhill to a tile inlet pipe. The tile inlet pipe accepted storm water from the hill to the north and another hill to the south. It then conveyed the flow to the east where it discharged storm water to a hillside.

IMGP0334: South wall of Compost Building had seepage from wall to hillside.

1. From the south wall of the Compost Building to the storm water pathway to the south.

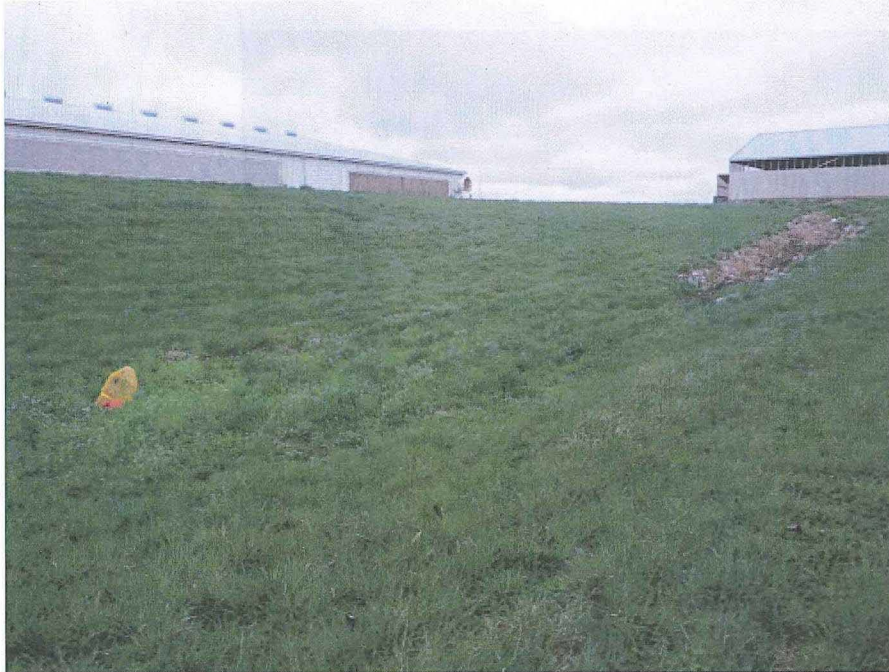
Location: East of Gestation 2 Building.

IMGP0335: Storm water pathway to storm water inlet. Compost Building is on the right in background.

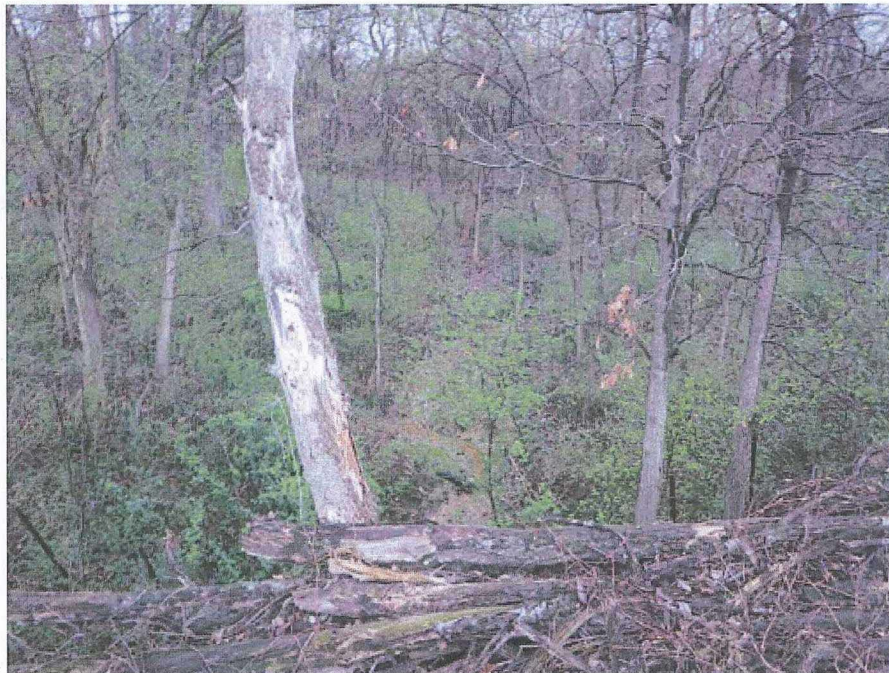
Location: East of Gestation 2 Building.

IMGP0337: Storm water outlet was to the east, down the hill and through the trees.

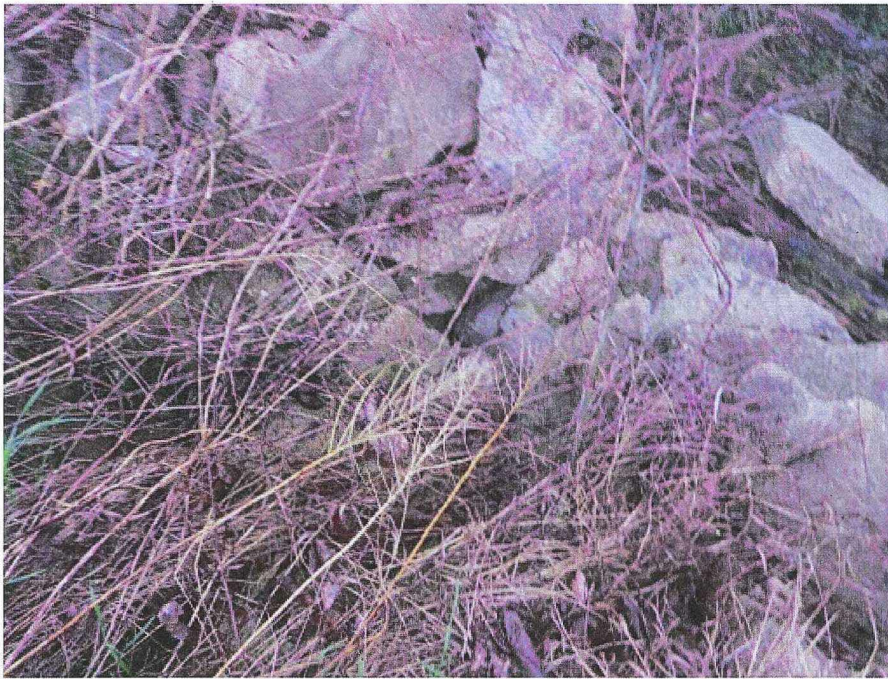
Location: East of Gestation 2 Building.

IMGP0338: Outlet for storm water pipe is under the rocks on east hillside.

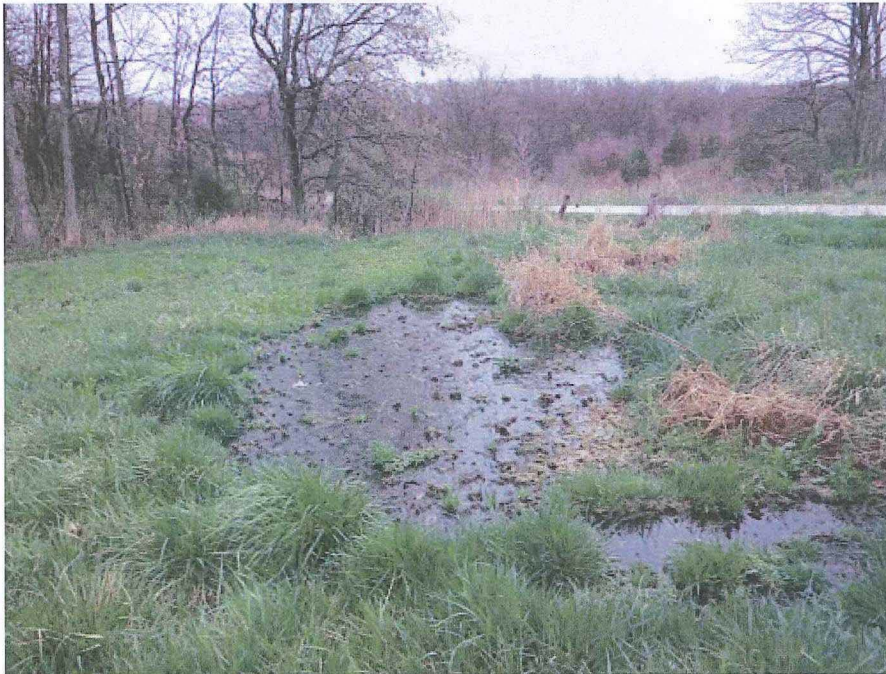
Location: Southeast corner of facility.

At the southeast corner of the production area, EPA observed what appeared to be the septic field for the facility. A standing pool of what appeared to be septage water gave the EPA inspectors the impression that the septic field was overloaded. The water flowed to the southeast to a roadside ditch for County Road 150. To maintain biosecurity precautions, Deer View employees must take a shower before entering the facility and before leaving. EPA speculated that the septic field was not originally designed to handle over 40 showers per day. Deer View representatives indicated that they would address this problem immediately.

IMGP0340: Septic field for facility appeared to be overloaded. Standing septage water flowed to roadside ditch.

1. Process wastewater from the septic field overflowed to a roadside ditch on the north side of County Road 150.

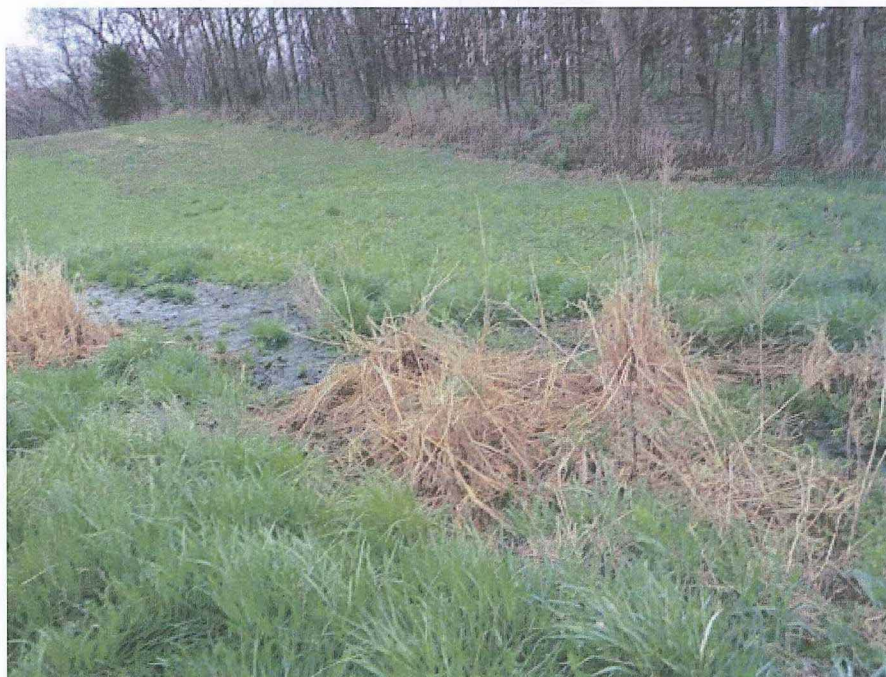
Location: Southeast corner of facility.

IMGP0341: Standing septage water flowed to roadside ditch.

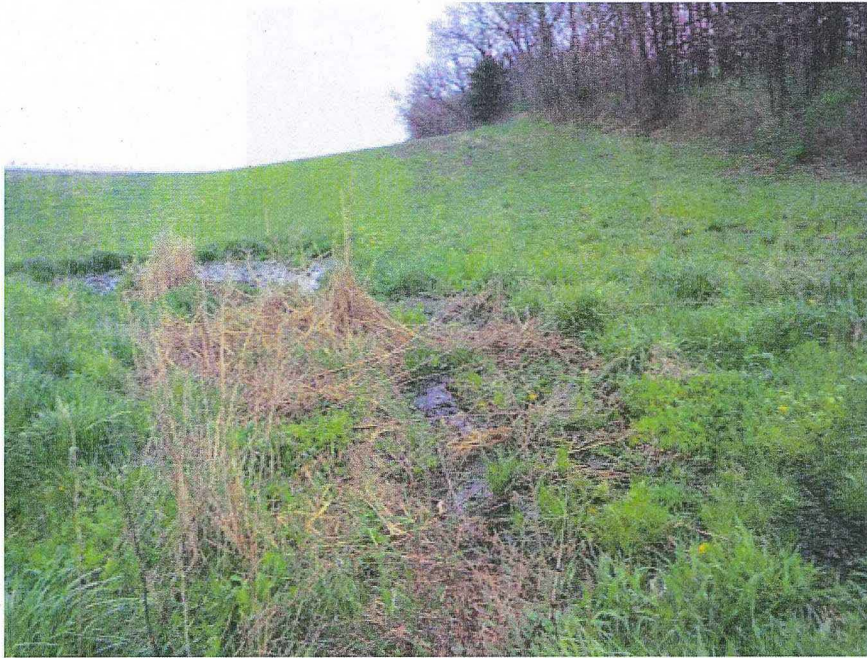
Location: Southeast corner of facility.

IMGP0342: Septage water from apparently overloaded septic field flowed down to the roadside ditch.

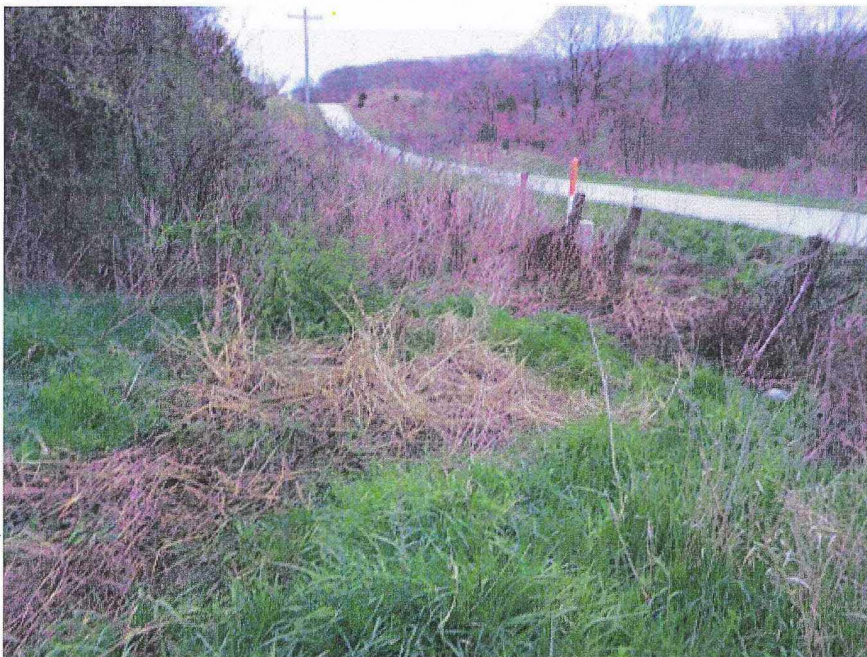
Location: Southeast corner of facility.

IMGP0343: Septage water from apparently overloaded septic field flowed down to the roadside ditch on north side of County Road 150.

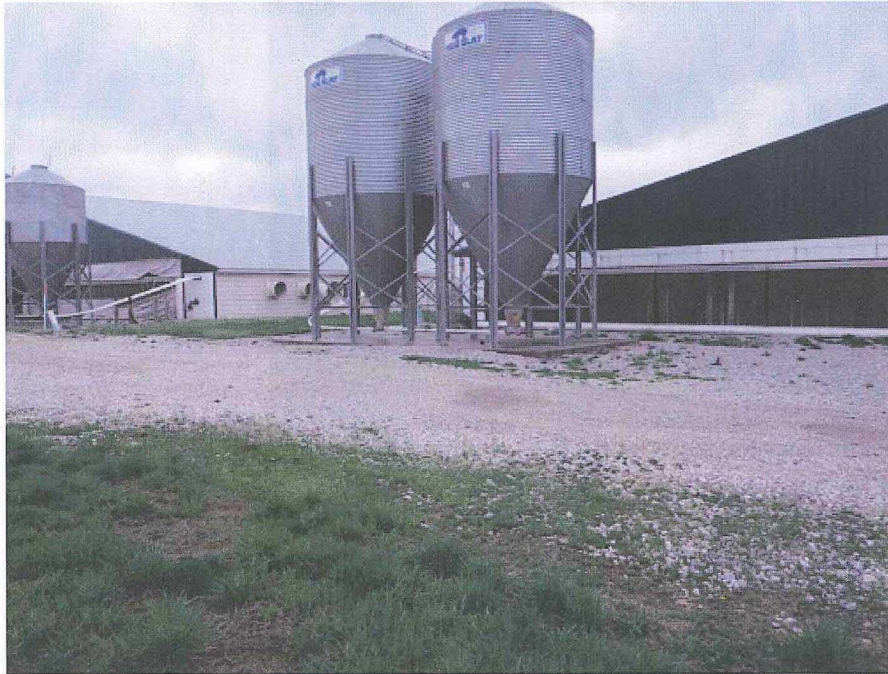
Location: South of Gestation 2 Building.

IMGP0344: Bulk bins on south side of Gestation 2 Building .

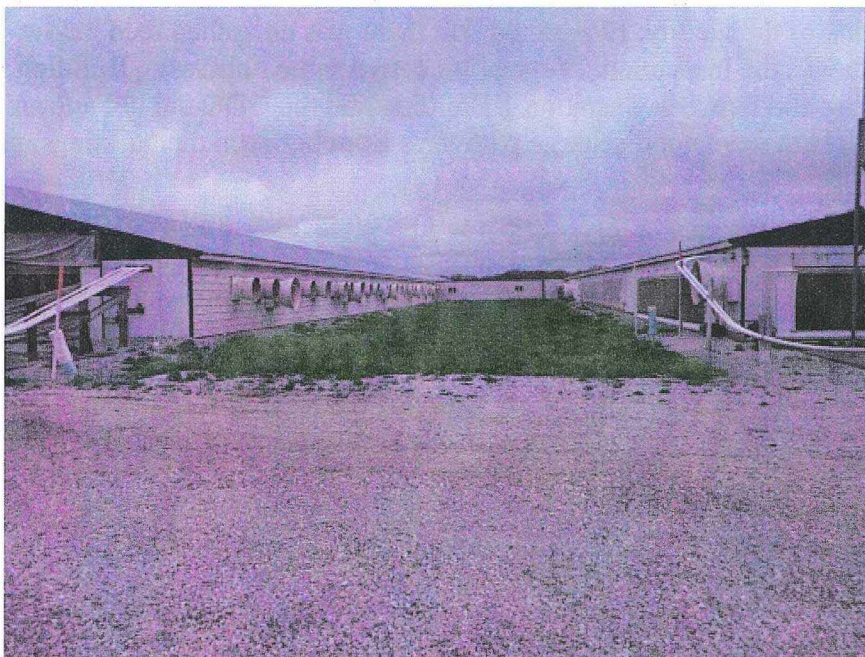
Location: South of Farrowing and Gestation 2 Buildings

IMGP0345: Vegetation between Farrowing Building and Gestation 2 Building does not appear to be nutrient burned.

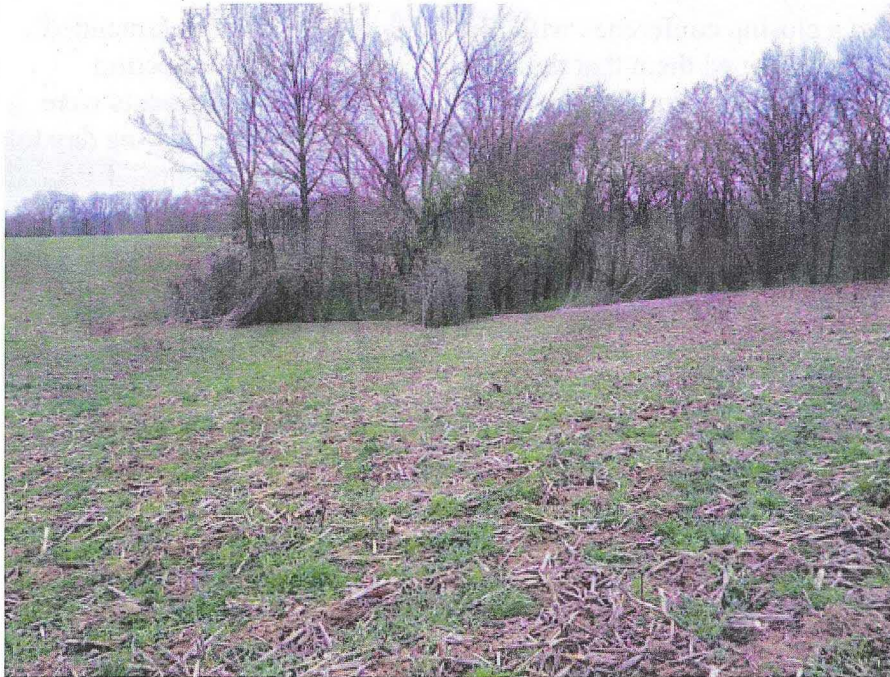
Location: At land application field.

IMGP0358: Observing setbacks from waterways was not feasible as the land application was conducted several months prior.
